Re: Property located at 100 Bosworth Street Providence, R.I. Leaking Tank Enforcement Case LS 2836

Re: Property located at 100 Bosworth Street Providence, R.I. Leaking Tank Enforcement Case LS 2836 20 December 1995

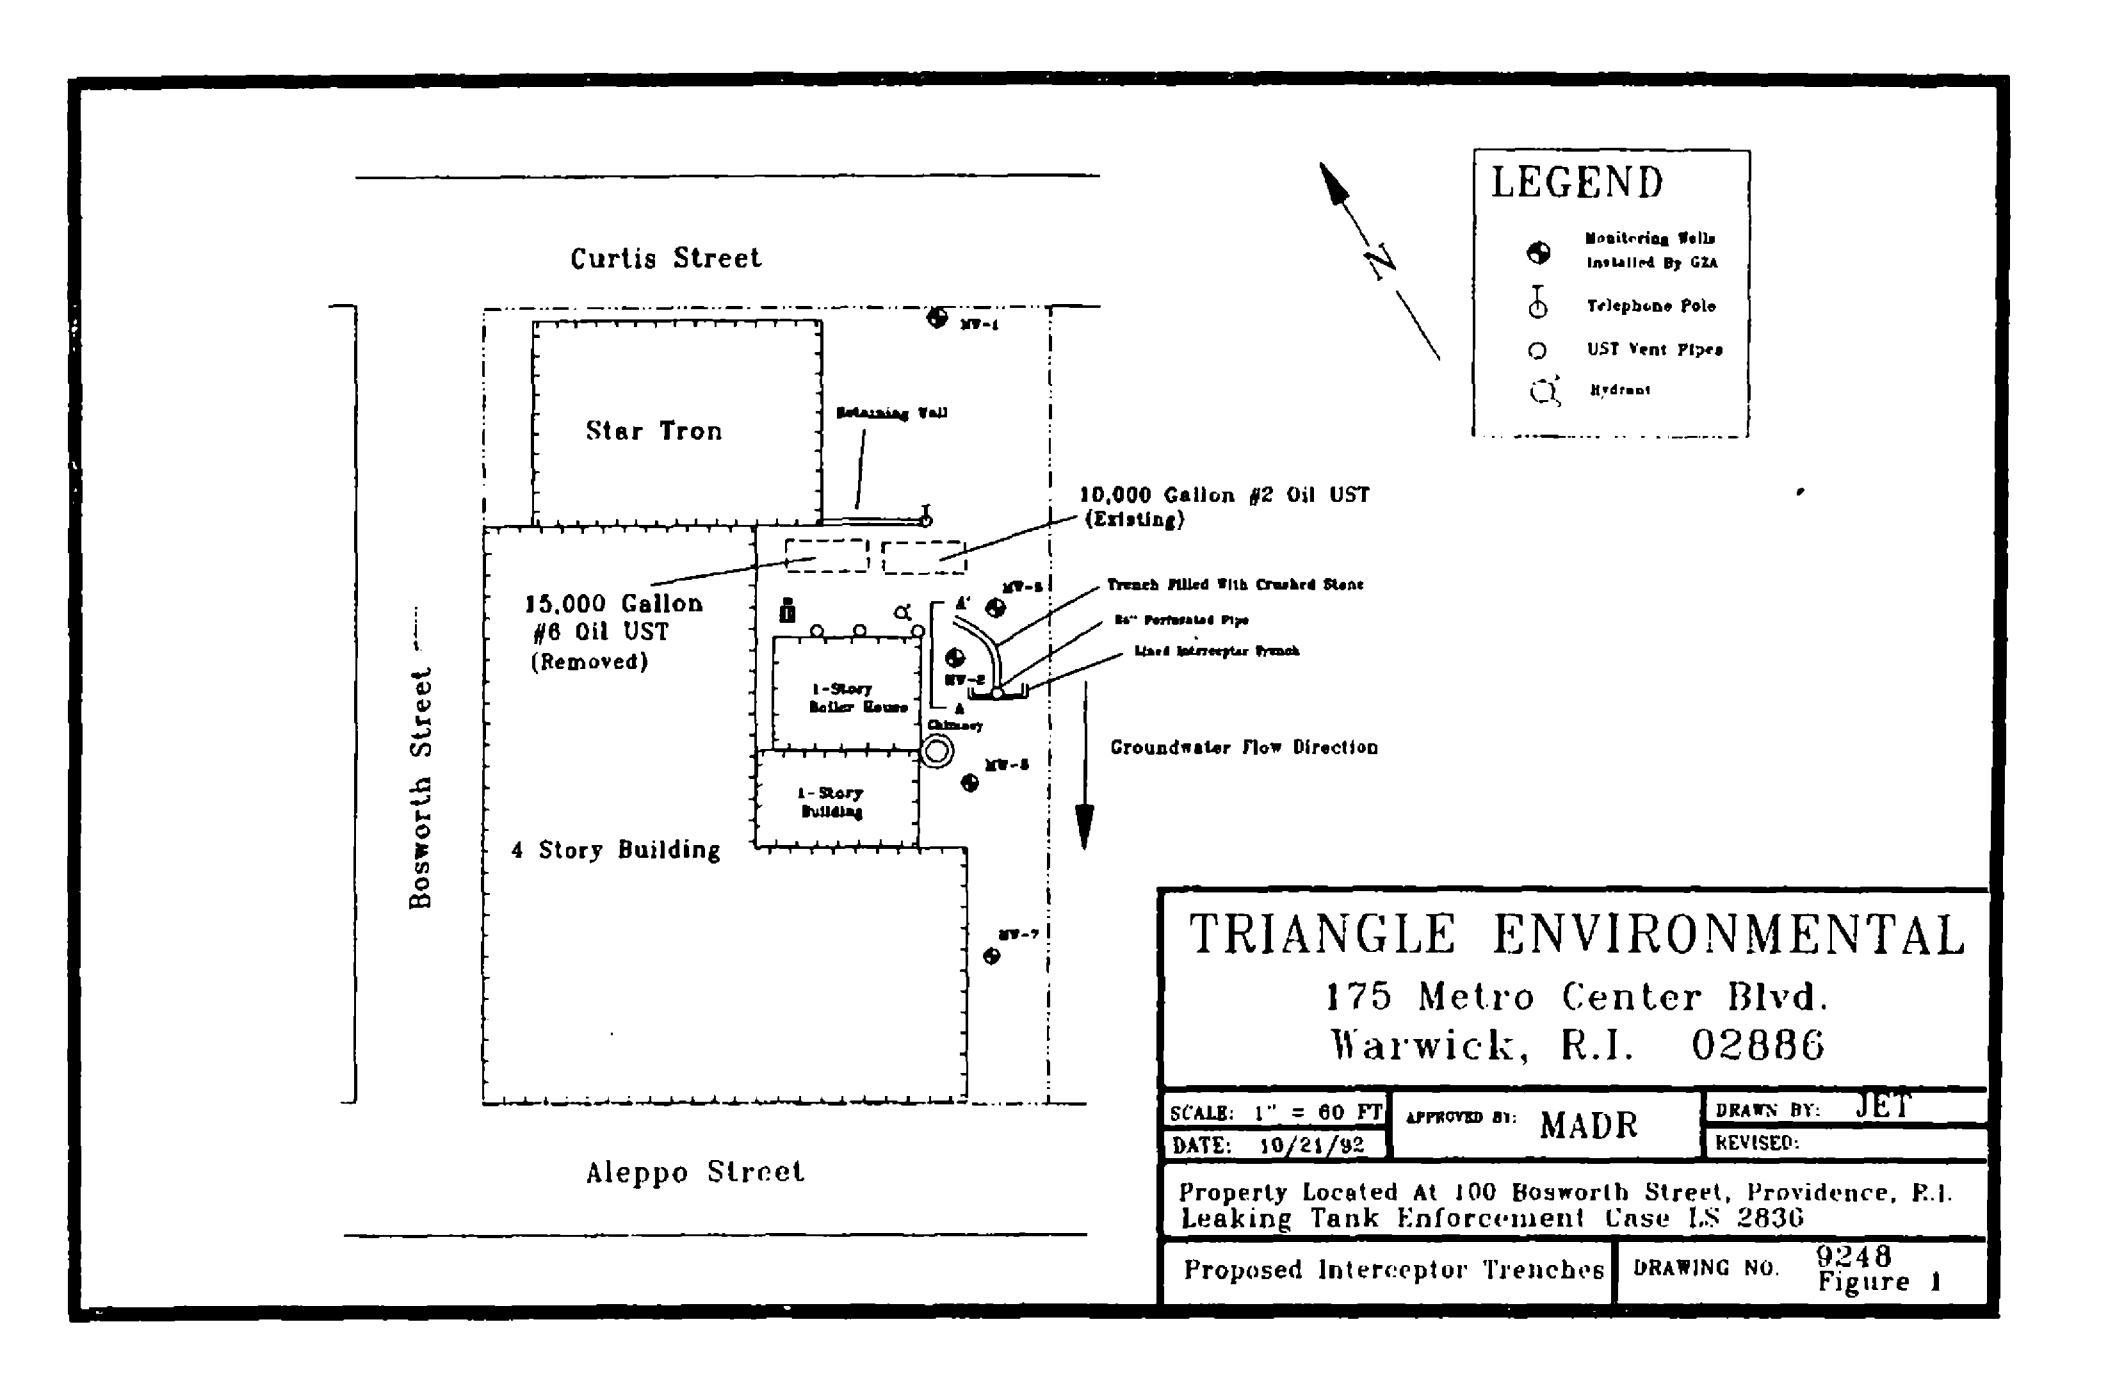
The remediation procedure would begin by excavating a trench approximately 10' - 14' deep into the groundwater at an area north of MW's #2 & #5 and south of the existing water hydrant. The digging would continue southerly until the oil saturated soil was no longer encountered. During the excavation, all oil saturated soil would be removed and placed on poly for proper disposal. As the trench is extended southerly, the previously excavated area would be lined with crushed stone. At the end of the excavation an intercepting crushed stone trench lined with a impermeable material would be installed. This trench would contain a 24" corrugated/ perforated pipe and would extend from the groundwater surface to grade. The gravel lined trench would, over a period of time, collect and divert oil toward the 24" pipe w/intercepting trench. A site plan of the existing property is depicted in Figure 1. A diagram of the system is attached as Figure 2 of this report.

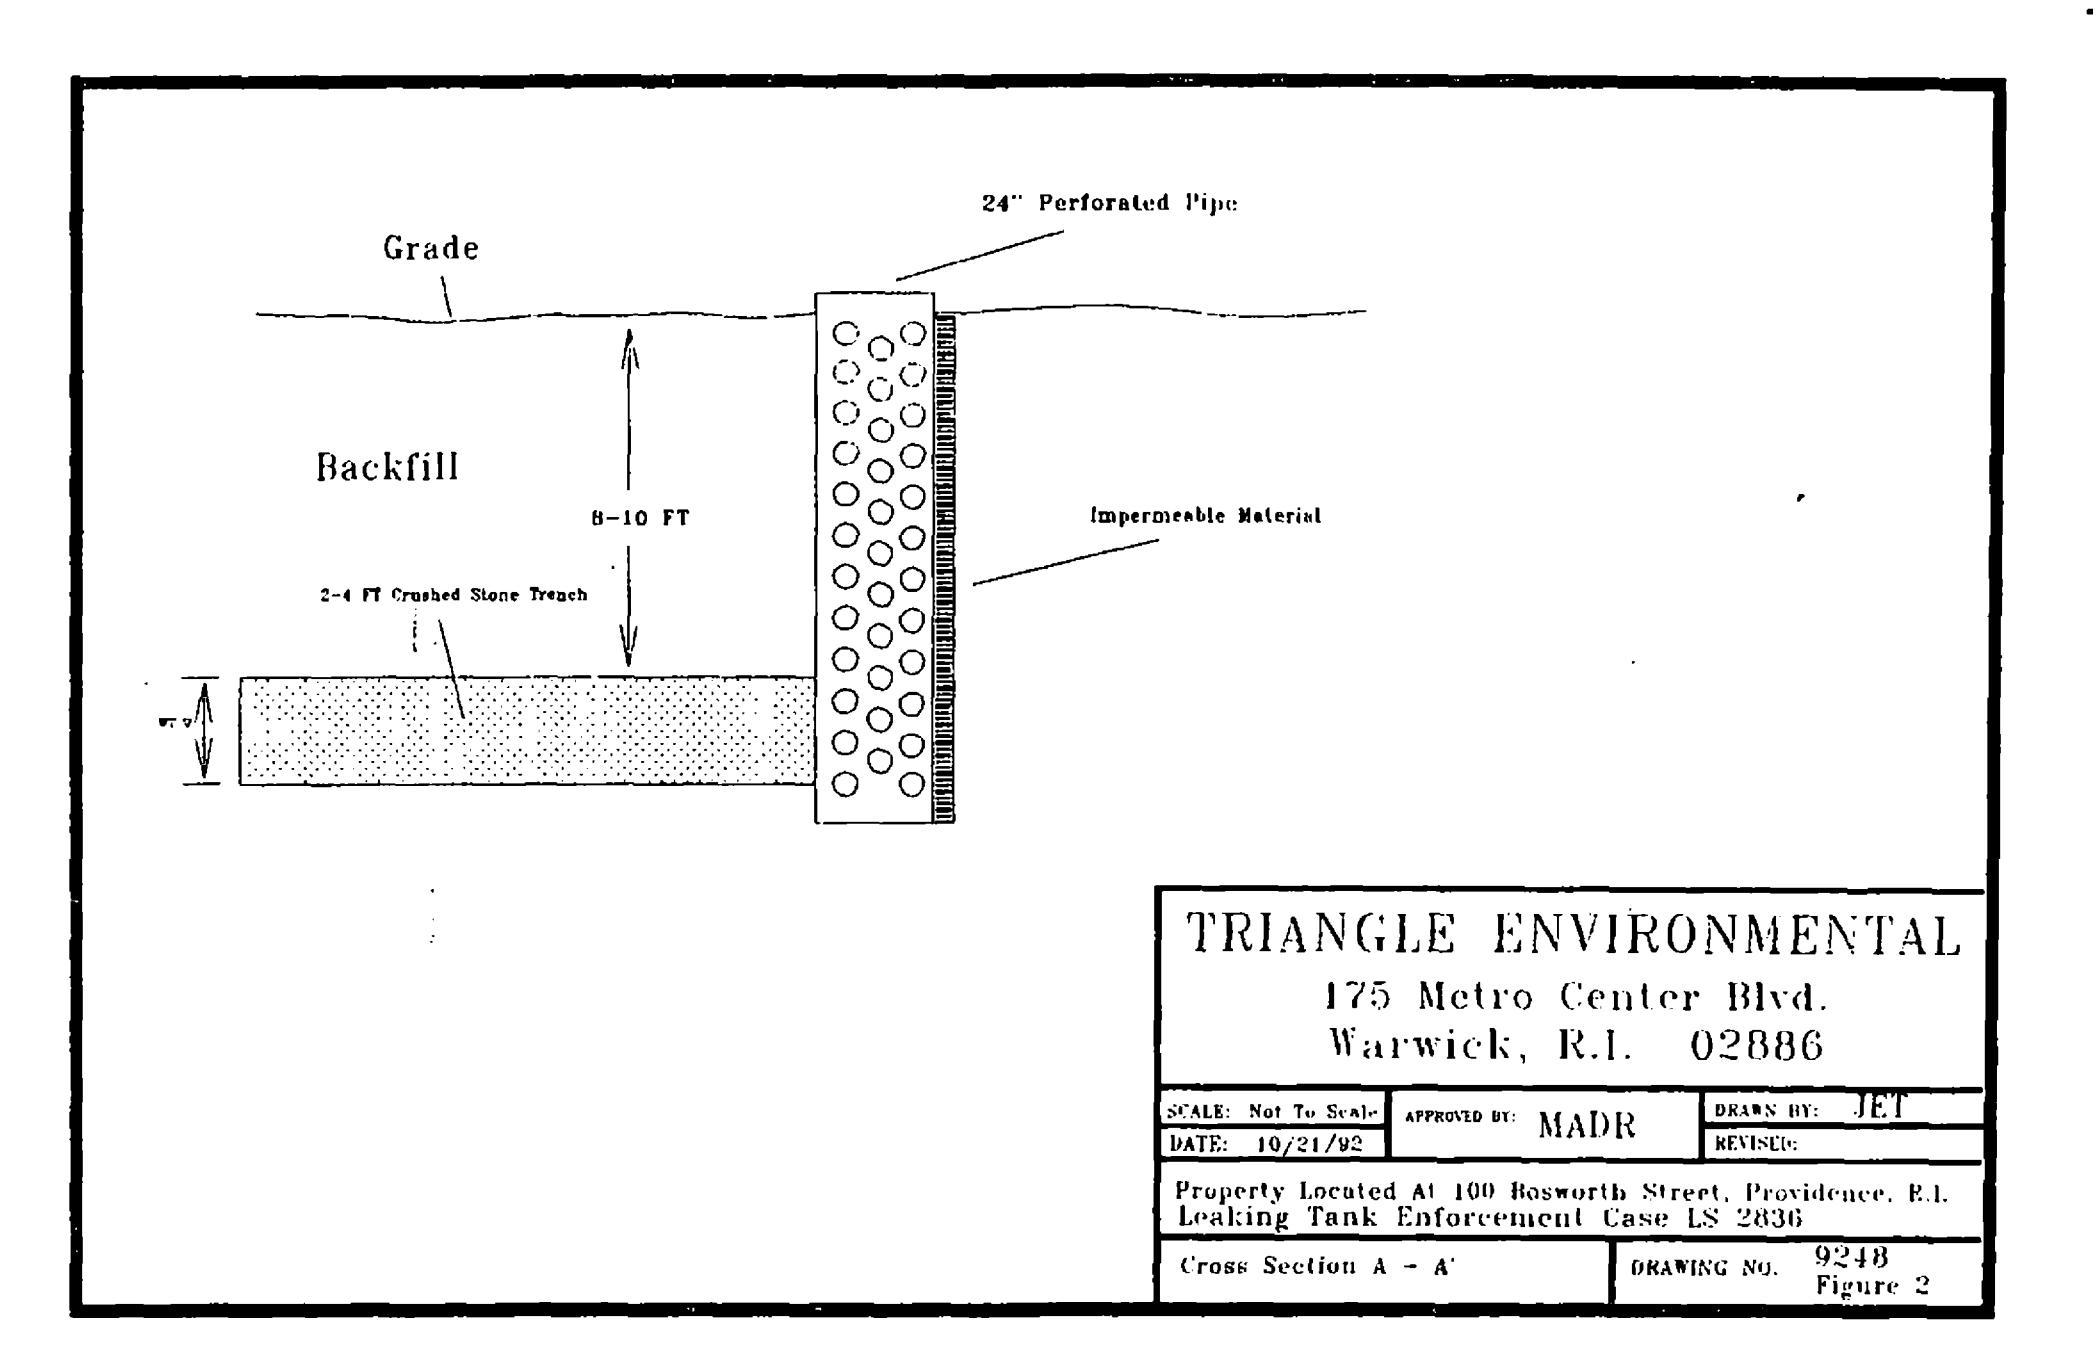
The remediation method recommended by Triangle Environmental would be the installation of recovery trench - product recovery system. A trench would be installed between MW #2 & MW #5. An intercepting trench would be installed downgradient of the excavation. Within this trench would be a 24" corrugated pipe lined with an impermeable material.

Initially this pipe would be monitored on a periodic (at least monthly) basis for free floating oil. The accumulated oil would be pumped into a vac truck for removal. Monitoring reports as well as pumped product would be submitted to your office for your review.
